LAKE COUNTY GOVERNMENT
DISTRICT 5 LAKE COUNTY
MEDICAL EXAMINER'S BUILDING
LEESBURG, FLORIDA

**FACILITIES CONDITION ASSESSMENT &
ROUGH ORDER OF MAGNITUDE ESTIMATE**

CMI No. J-969

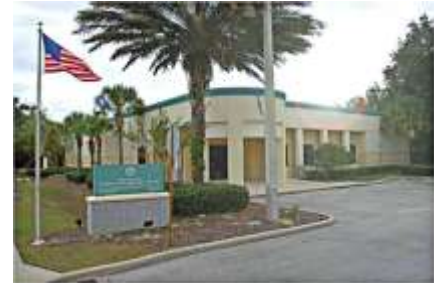
Constructed in year 2000, the building currently houses the District 5 Medical Examiner. The facility consists of a single-story building with an auxiliary generator and HVAC equipment located at the south and east ends of the building. The building is approximately 8,770 sf of enclosed floor area and a garage of approximately 1,265 sf. The space includes offices (including Doctor's), cooler, morgue, storage and supply rooms. It is assumed that the building walls rest upon spread footings and the interior structural columns rest upon isolated concrete column bases. There are no signs of damage or settlement. Exterior walls consist of a combination of pre-cast panels and concrete masonry units and are generally in very good condition. The exterior doors and windows are glazed in metal frames. The corrugated metal roof deck is supported by steel bar joists and structural members. The roof is a low slope, membrane on insulation system which was reported to have been recently replaced. The building is fully sprinkled.
