Preliminary Assessment on the Feasibility of Plugging an Artesian Well

Parkstone Development – City of Winter Springs

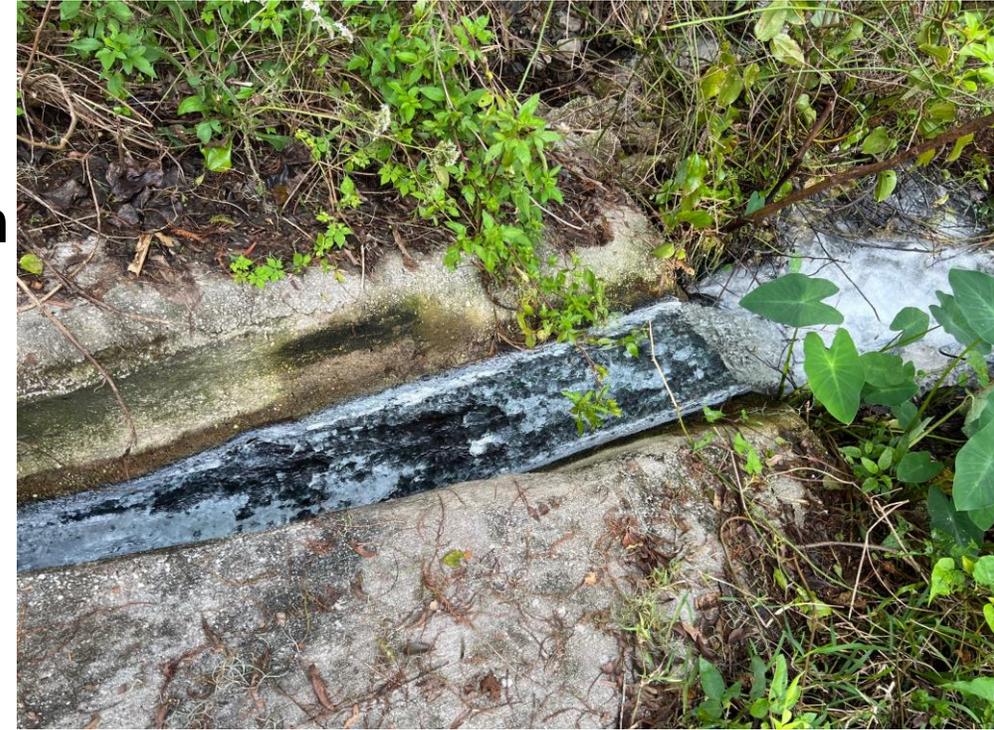
ARTESIAN FLOW
CONTAINMENT
STRUCTURE

DISCHARGE PIPE
TO LAKE JESUP

- Parkstone residential development has an artesian (naturally flowing) source of groundwater.
- Artesian flow continuously discharges into Lake Jesup at reported 0.5 million gallons per day for over 20 years.
- Infrastructure was installed at time of Parkstone development to capture the artesian flow and discharge it to Lake Jesup.
- Parkstone HOA desires to have this well plugged to avoid further costs associated with repair and maintenance.
